TP 13217E

**Review of the Damaged Stability Provisions
in the High Speed Code**

Prepared for
Transportation Development Centre
Safety and Security
Transport Canada
(by Fleet Technology Limited)
March 1998

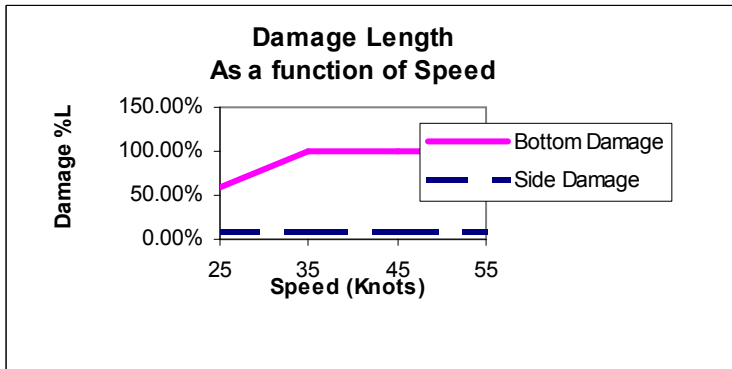
Figure 3.1(a) As a Function of Speed

The results of the use of the proposed new formulae for a typical 40 m catamaran of 160 t displacement and a maximum design speed of 35 kn, along with variations in key parameters, are shown in **Figures 3.1(a) to (c)**. There is a concern that the formulae can calculate a damaged length that is longer than the vessel length, in which case the formula should state that (obviously) the vessel length is taken.

There is provision that the bottom damage will never be less than the side damage. Typical side damage results are also shown in the Figures 3.1(a), (b) and (c).

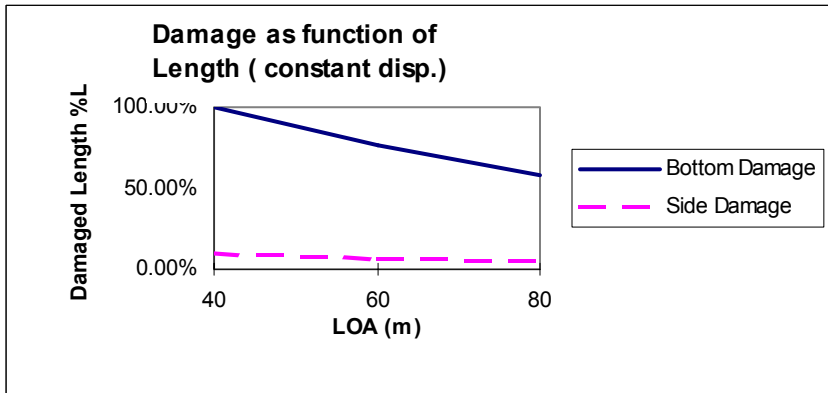
Figure 3.1(c) As a Function of Vessel Length
